Riverbank Erosion & Consequent Land Settlement Issues: A Case of River Chenab, District Hafizabad

Original
Article

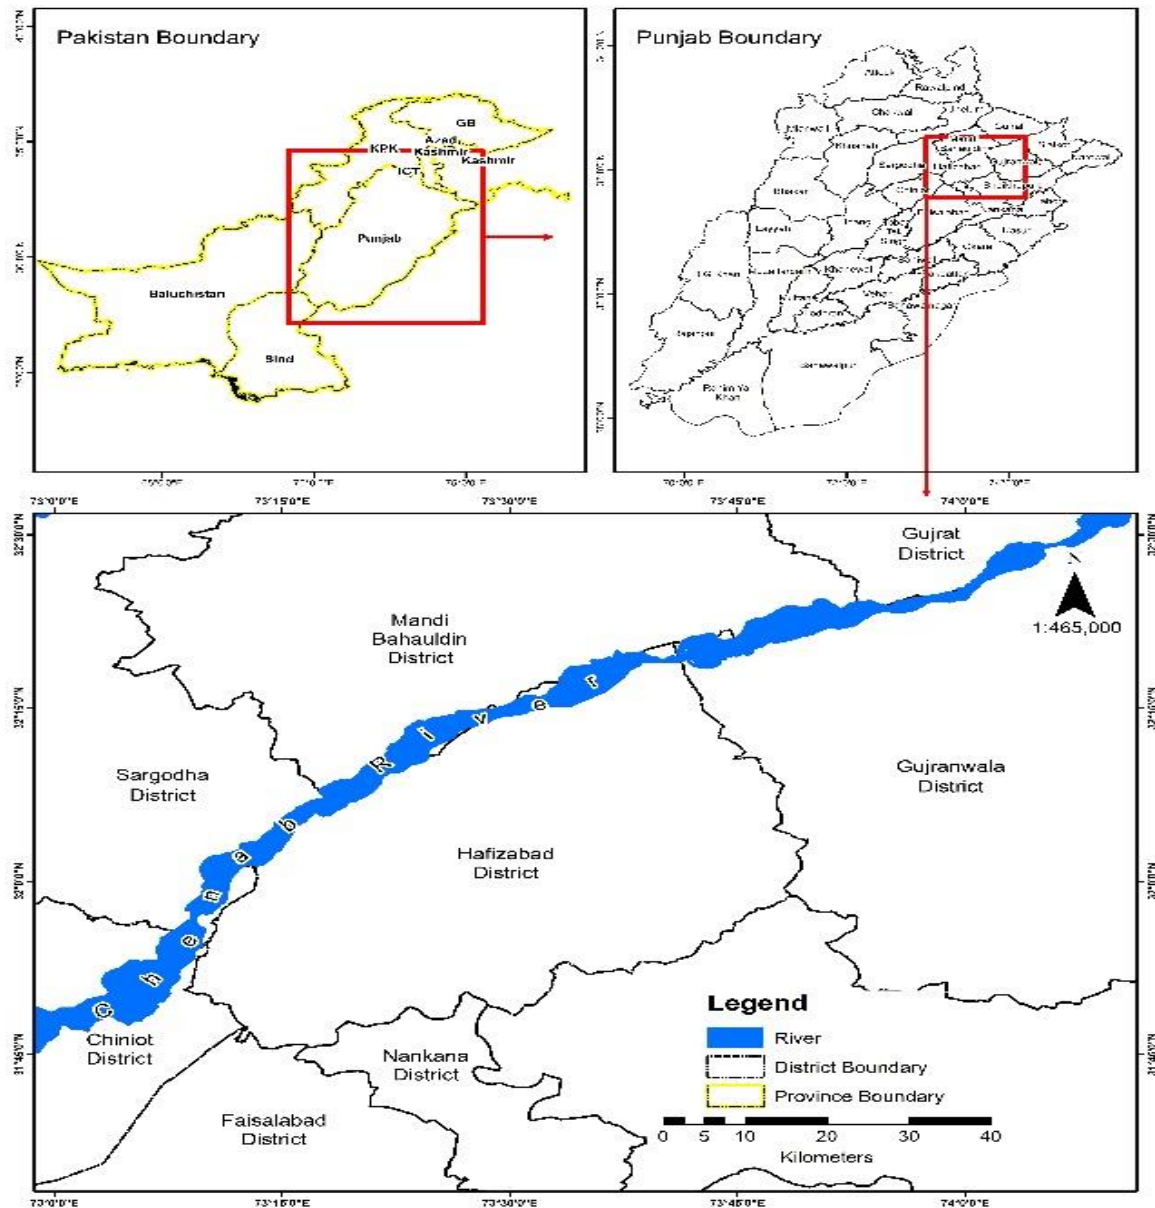
Figure 2. AOI of the Area

The Area of Interest (AOI) along the Chenab River inside District Hafizabad is highlighted with the red color rectangle in Figure 2 below:

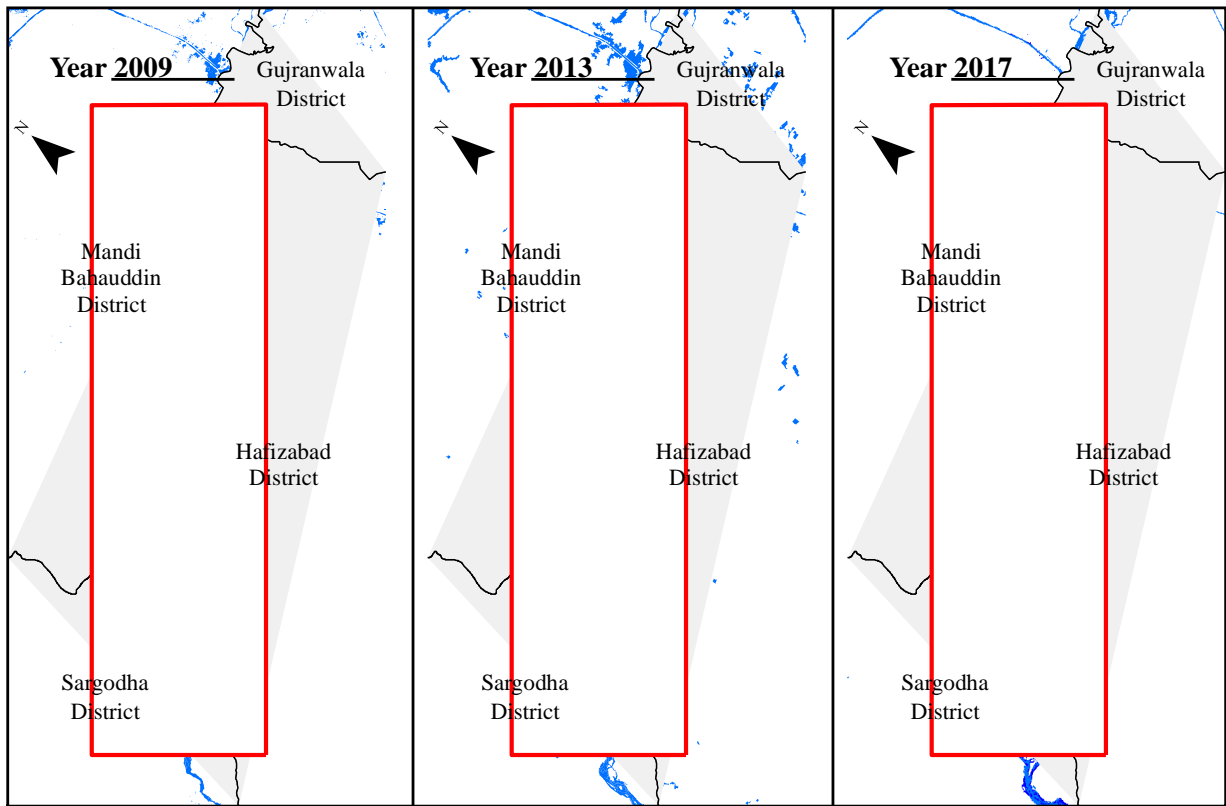
Figure 3. Chenab River channel course by the time

Object-Based Image (OBI) Classification technique has applied to aforementioned periods' Landsat satellite images to find out the river course change occurred with the time frame.

The separate results of the Chenab river course observed for years 2009, 2013 and 2017 are as shown below in Figure 3:

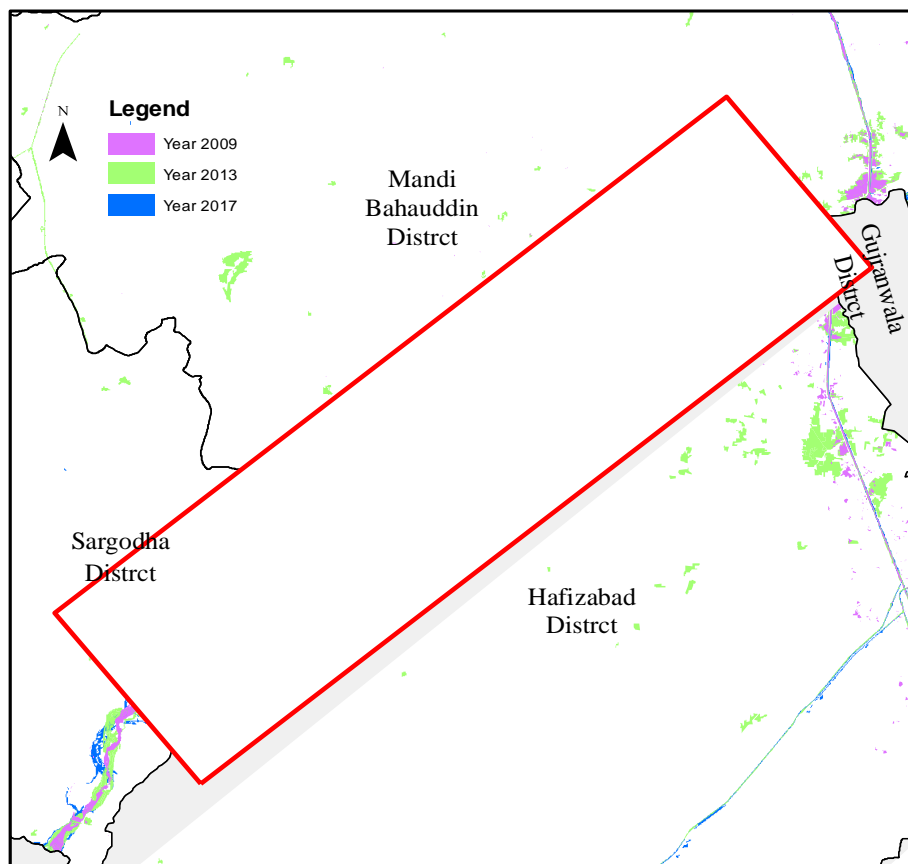
Figure 4. River course for years 2009, 2013 & 2017

The comparative picture of all three years' results is shown in Figure 4 below

Above, Figure 4 is important to identify the hotspots in AOI where river course change may be more prominent with rapid change rate and helps to find valuable locations. RS and GIS are efficient tools for change detection [12]. For a layman, change in the river course is just morphological change but in reality, it disturbs the fertile land and leaves concerned families deprived. Riverbank erosion causes destroyed land, livelihood and eventually compelled the people to migrate [13, 14].

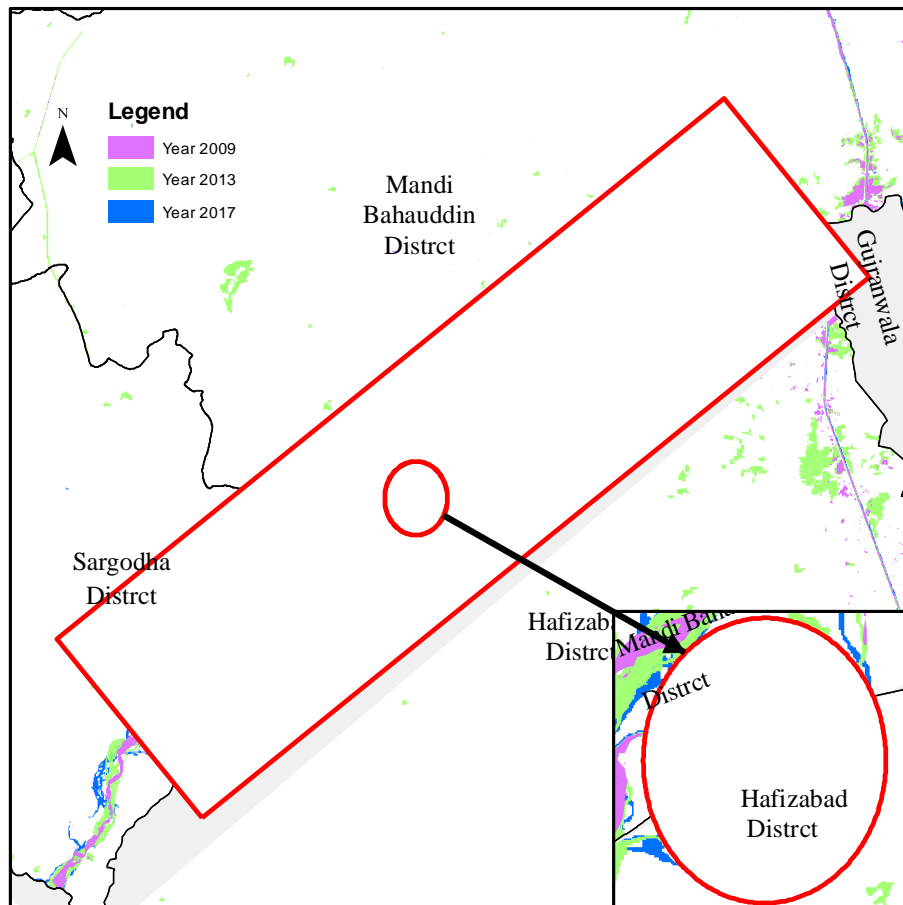
Figure 5: A selected hotspot for identification of deprived families

families through revenue records. For this purpose, there is a need to select one of the hotspots from our AOI as shown in Figure 5 below:

In Figure 5 above, supports the identification of the river erosion hotspots. Here to proceed, only a single hotspot in District Hafizabad, “Chak Bhatti” along the Chenab River (left bank) has been selected for detailed working. This position is available at 73.39 E, 32.16 N.

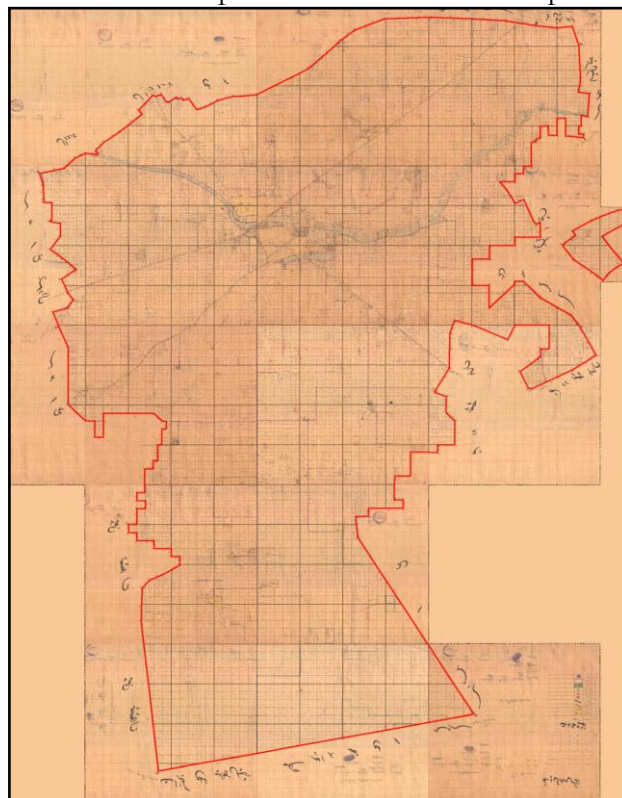
Figure 1. Massavi map (revenue record) of Chak Bhatti, District Hafizabad

For precise identification of deprived families due to river erosion phenomena, there is a need to register the revenue land record document (Massavi map, contains individuals’ land ownership information). It is possible to make geo-referencing of Massavi map, applying the GIS techniques [15,16]. For the said purpose, the Massavi map of “Chak Bhatti” (shown in Figure 6 below) can be geo-tagged and the processed Massavi map results are shown in Figure 7 below:

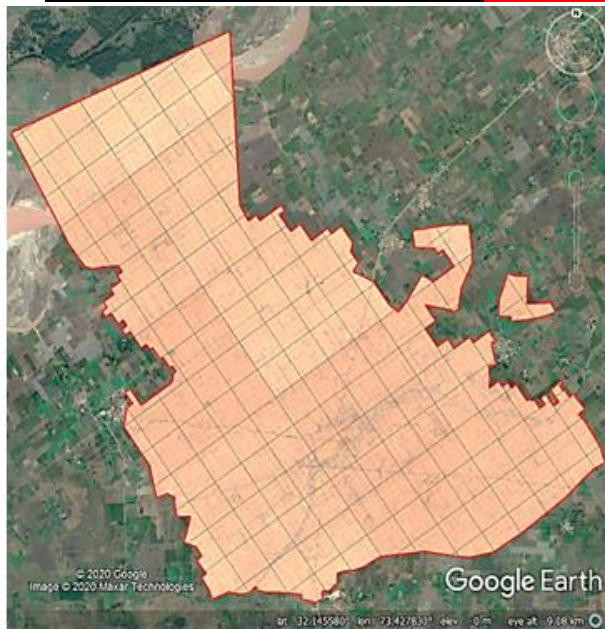
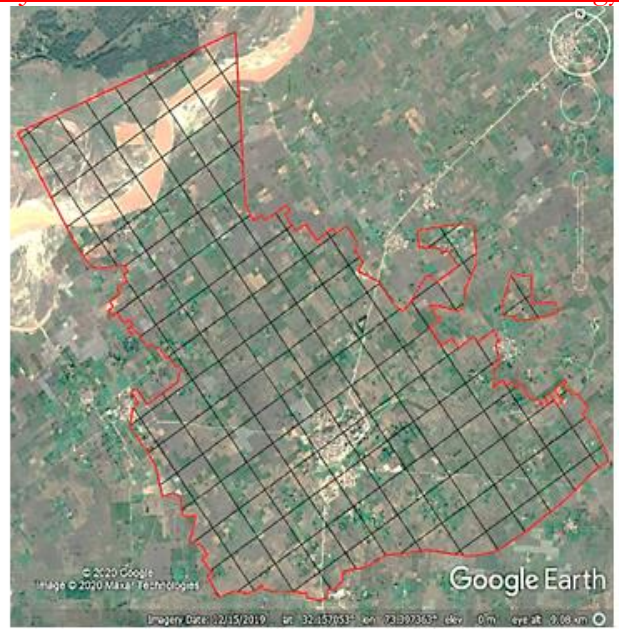
Figure 7 and Figure 8 are showing comparative pictures and ground linear features can be matched easily for evaluation as well.

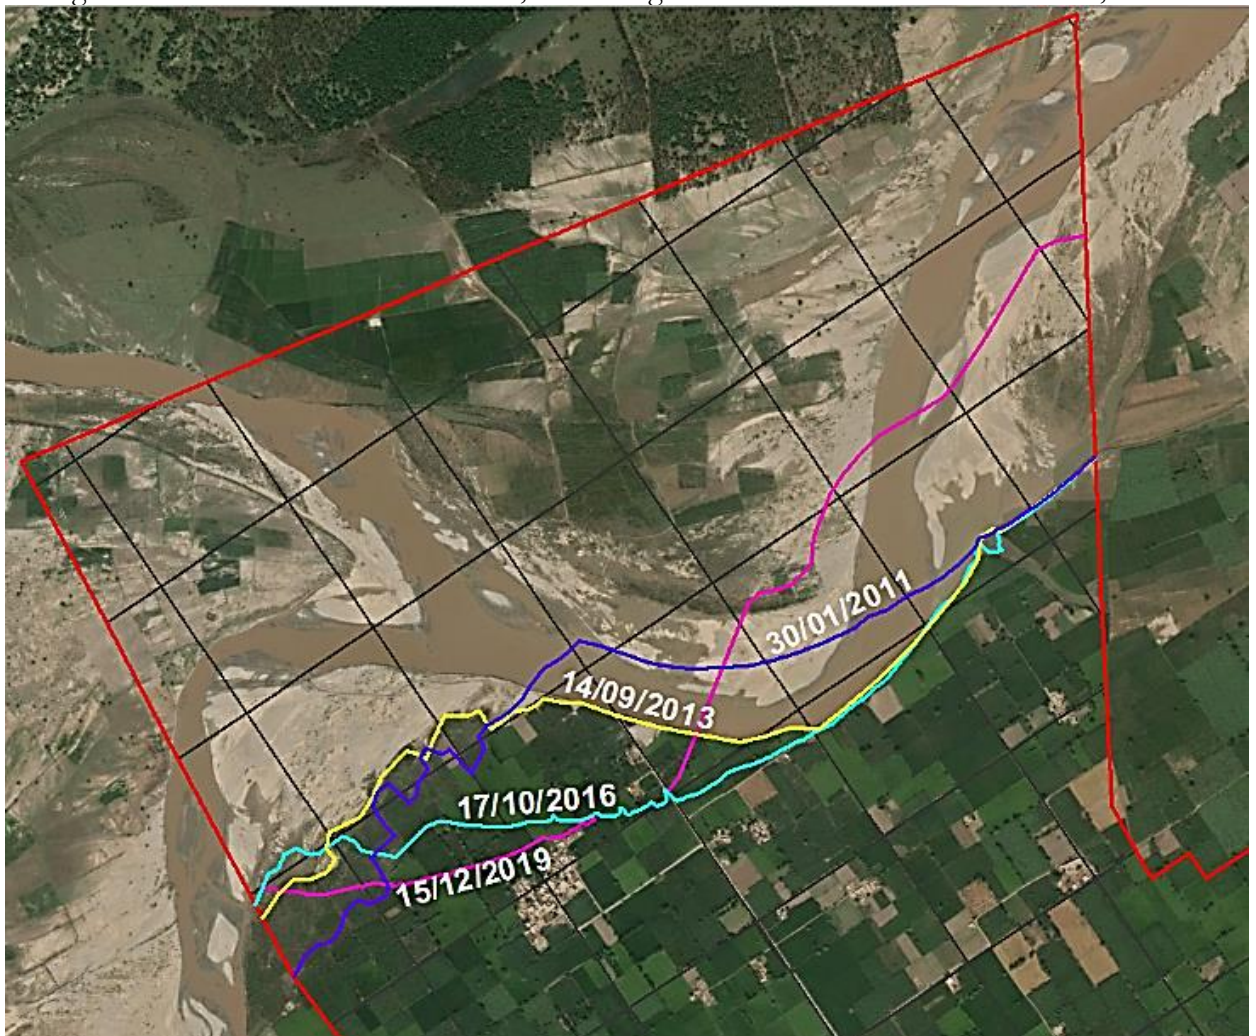
Figure 13. All time riverbank shifts' comparison

Figure 13 shows that how the riverbank is eroding land with time, it also shows that riverbank displacement from 2013-16 is more than any other span which reflects the effect of

2014's super flood faced during this period. The joining points of riverbank displacement lines between 2013-16 and 2016-19 show 448m and 162m shift in South-West along with the river flow, respectively. This shows that the average riverbank displacement due to erosion phenomenon at this location was 12.1m/month and 4.4m/month during 2013-16 and 2016-19, respectively. The victims face economic, social and health insecurities and make families' life more vulnerable [20], however, regular monitoring of riverbank erosion values and soil degradation can help to foresee the situation [21]. Families settled along the riverbank used to face many problems in their daily life due to issues like frequent floods and riverbank erosion [22]. On the other hand, bad governance also acts as a catalyst for the miseries of the affected community [23]. Therefore, it is needed to monitor the erosion phenomenon on regular basis to save the vulnerable communities otherwise it may turn to serious consequences as well [24]. Many remedial measures may be taken including concretization, plantation, desilting, use of nut-fibers and synthetic erosion-resistant mats [25]. Soil can be divided into different types based on erosion rate and accordingly plantation plans can be suggested, like land with heavy grade erosion can be planted by sugarcane and with low grade erosion can be corn or rice [26].
